# All Shook Up

By Hillary A. Lichtenstein

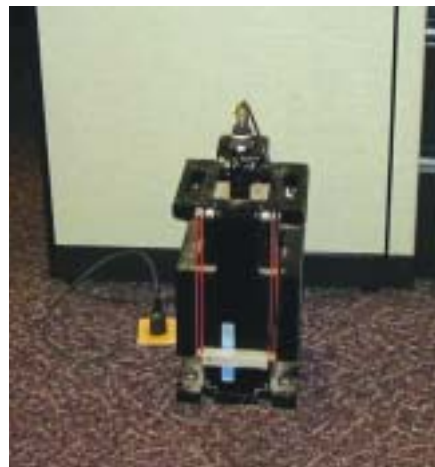
An active control system for reducing unwanted floor vibrations. The system installed in the New Jersey office building was approximately 20" tall and "camouflaged" in an enclosure to blend with the office furniture.

Hanagan's solution is what she calls an "active control system." The active control device is composed of four primary parts: an electromagnetic proof-mass actuator, an amplifier, a velocity sensor, and an electronic feedback controller. The velocity sensor detects the motion of the floor; the electronic feedback controller responds to the velocity signal by sending a control signal to the actuator; the control signal makes the reaction mass of the actuator move to generate the control forces that add damping and counteract the resonant

motion of the floor. In the case of the New Jersey building, the active control system uses a 100-lb weight attached to a 20"-high linear motor.

"We came in on a Saturday to try it out, and it was up and running within hours," said Duffy. "The system just sits on floor, and we covered it to make it look like a file cabinet. It's really a self-contained unit, and it can be placed anywhere you have a problem." In fact, Hanagan noted the device could even have been installed in the ceiling cavity below. The device has been successfully operating in the building since November 2002.
