Planning to Grow

By Chad O'Donnell, P.E.

Saint Mary's Hospital is a \$46 million, 44-acre integrated health care campus that provides a full range of diagnostic, testing, laboratory, inpatient, outpatient, and emergency services. Unique elements, made possible by the strength and flexibility of structural steel, help give the hospital a distinctive look while maintaining the main goal of providing high quality patient care.

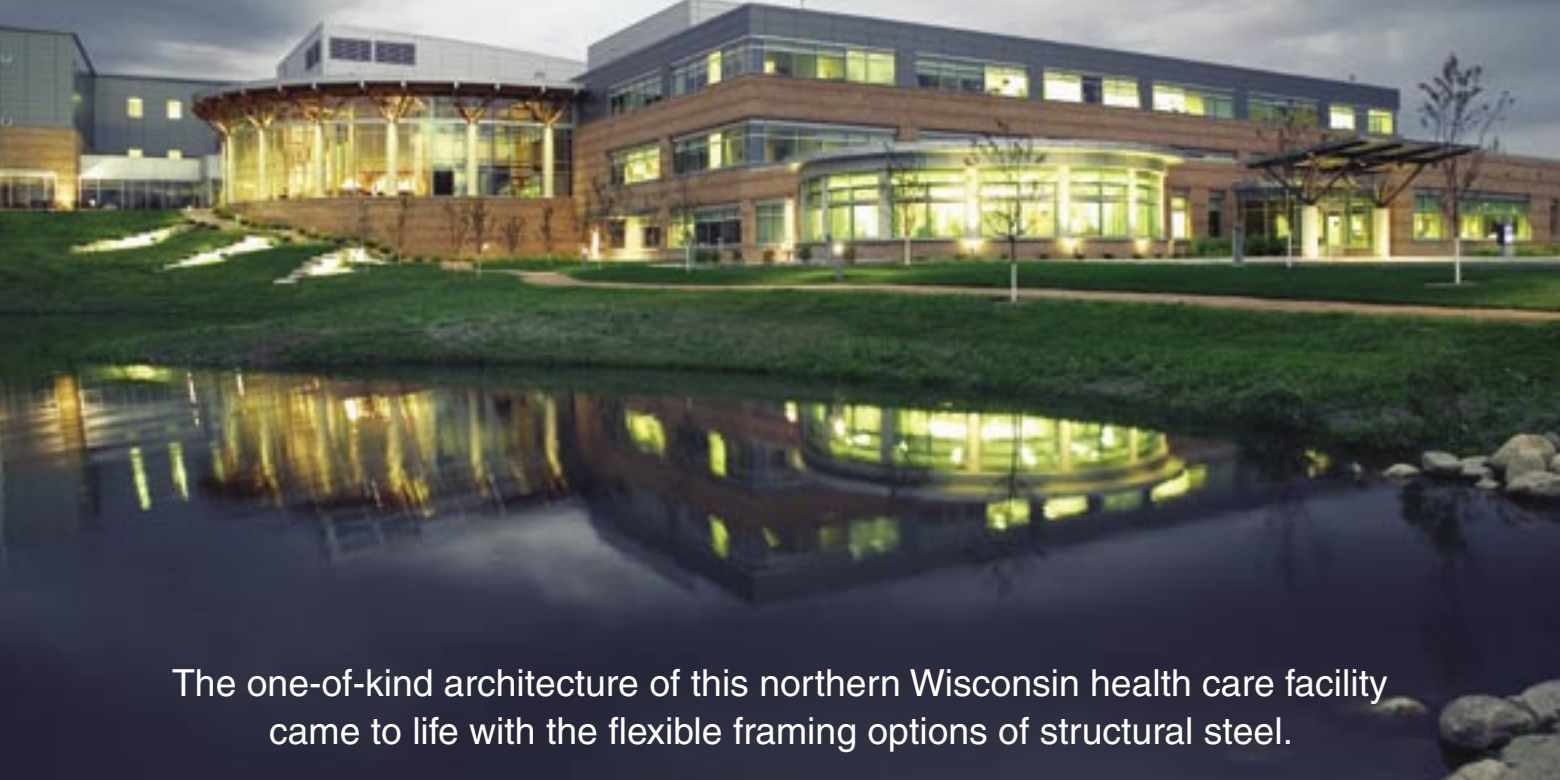
The one-of-kind architecture of this northern Wisconsin health care facility came to life with the flexible framing options of structural steel.

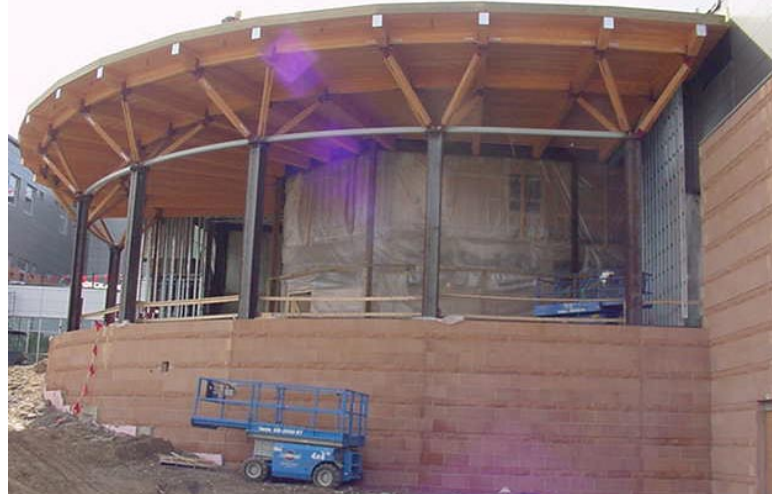
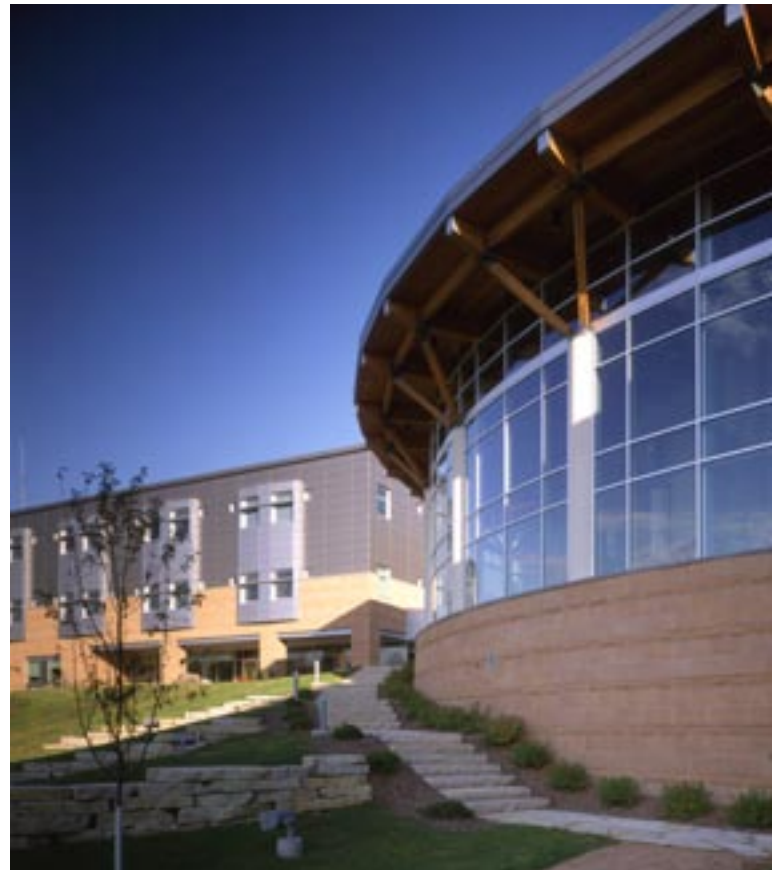
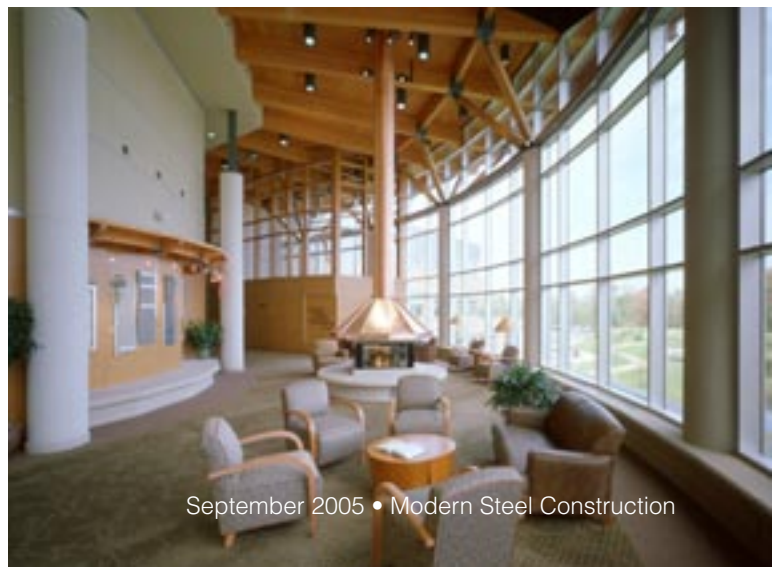
This page: The extensive use of wood framing for the Community Center's roof required that it be structurally isolated from the rest of the hospital to meet fire code requirements. Photos courtesy Hammel, Green and Abrahamson, Inc.

ment. The Community Center is a curved, 25'-tall space surrounded by glass that overlooks a large pond and a dense grove of trees. It is framed in wood and contains a custom-built copper fireplace giving patients, visitors, and staff the sense of being in a cabin.

To achieve the desired look of the space, HGA's designers wanted to use as much exposed wood framing as possible. This resulted in many challenges for the design team. Codes discourage the use of combustible material in a hospital for obvious reasons. In order to use wood framing and still meet the requirements of the code, the Community Center needed to be completely separated from the rest of the facility. This meant providing two-story fire doors at each end of the space to seal it off in the event of a fire. It also meant structurally isolating the space from the rest of the facility, which was easily done from a gravity perspective but did not leave many options for dealing with lateral loads. Because the roof is wood, moment frames were not an option, and the openness of the space precluded the use of

bracing. This left cantilevered steel columns, buried in the glass, and an exterior curtain wall as the most logical choice.

Like the canopies and the entries, the Community Center framing is meant to resemble the surrounding trees. Seven W14x120 columns, oriented so the strong axis is perpendicular to the exterior wall, are cantilevered 18' off the foundations to pick up the forces from four 6 $\frac{3}{4}$ "x6 $\frac{3}{4}$ " glulam struts that support the wood roof framing above. The tops of the columns are tied together with curved HSS 6x6 members. This helps distribute the lateral loads between the columns and provides the stiffness necessary to support the glass walls. A second row of steel beams and columns along the interior side of the space picks up the other end of the roof beams. The result is a welcoming, light-filled space that serves as the center of activity for the facility. ★

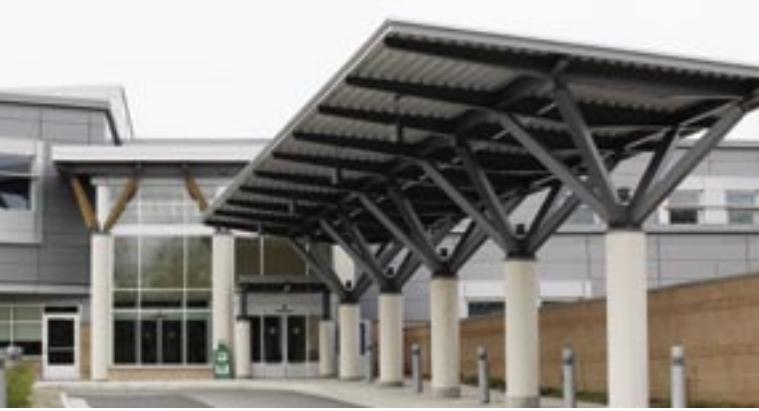
The steel framing of the entrance canopies supports the roof deck with tree-like branches of HSS. Photo courtesy Hammel, Green and Abrahamson, Inc.

The first element patients encounter when arriving at the Saint Mary's campus are exposed steel drive-up canopies. One serves the inpatient entry on the east side of the project; a second serves the outpatient and emergency department entries on the south side of the facility; and a third, smaller version serves the oncology entry on the west side of the campus. The canopies were designed to mimic the look of trees in the surrounding woods, with tube steel "branches" springing from "tree trunk" steel columns to support the exposed steel framing overhead.

The canopy roofs consist of 3" steel roof deck, exposed to view on the underside, attached to tapered W18x50 beams, and spaced about 10' on center. The beams are supported by HSS 8x8 struts that are welded to a stiffened plate on top of W12x87 steel columns at approximately 45 degree angles. This was a particularly challenging connection to detail because the forces in the struts at this point are large and roof drains and sprinkler piping are hidden within the struts at each column. In addition, lighting for the canopies is located between the struts, so plates were added to the connection to provide a mounting location for the lights. The columns are cantilevered off the foundations to resist lateral loads and are wrapped in round pre-cast concrete column covers to give them a finished appearance. All steel, except the columns, is exposed to view and was fabricated to meet the requirements of architecturally exposed structural steel. A high-performance paint system was used throughout the canopy to protect it from the weather.
